**Flood Control Project Maintenance  
Levee Inspections**  
**LMA District Cover Sheet**  
**Spring 2009 Levee Inspection Results**

**Reclamation District No. 2063**

**Levee Inspection Report By Mile - Spring 2009**

Waterway	Bank	Unit Miles	Inspection Start/End	Inspector
Unit No. 01 San Joaquin River	Right	10.60	04/21/2009 04/21/2009	Richard Willoughby

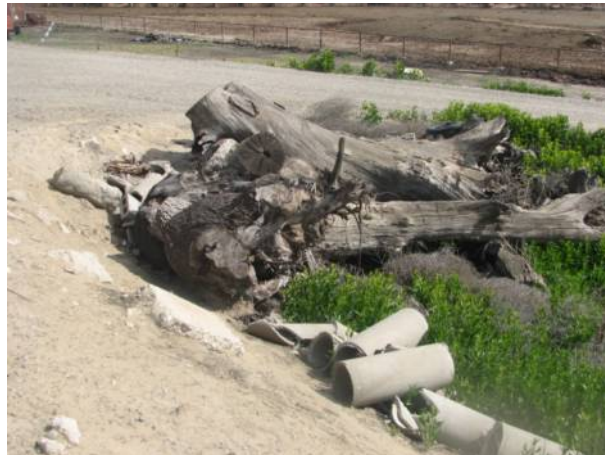
Levee Mile Report Line	7
Start Levee Mile	1.89
End Levee Mile	1.89
Location	Land Side
Category	Earthen Levee
Item	Encroachments
Concrete and tree stumps on landside slope at LM 1.89

6	1.39	1.39	Earthen Levee	Animal Control	LS	M	No rodents visible, but rodent burrows visible; need to backfill and compact or grout borrows.	37.463875 ° -121.032355 °	37.463875 ° -121.032355 °		971
7	1.89	1.89	Earthen Levee	Encroachments	LS	M	Garbage Inspector Comments: Garbage should be removed landward toe.	37.457160 ° -121.033743 °	37.457160 ° -121.033743 °	Y	5
8	1.92	1.92	Interior Drainage & Piping Systems	Sluice / Slide Gates	WS	U	Inspector Comments: Screw gate buried, not able to operate.	37.456745 ° -121.033795 °	37.456745 ° -121.033795 °	Y	6
9	2.09	2.09	Earthen Levee	Trim / Thin Trees	LS	M	Trim trees to at least five feet above ground level.	37.454593 ° -121.032530 °	37.454593 ° -121.032530 °		972
10	2.66	2.66	Interior Drainage & Piping Systems	Flap Gates	WS	M		37.448247 ° -121.026508 °	37.448247 ° -121.026508 °	Y	8
11	2.72	2.72	Boat Survey	Boat Survey Erosion	WS	M	Inspector Comments: Sinkhole; 7'x7'x2' Not able to verify sink hole	37.447450 ° -121.026090 °	° °		966

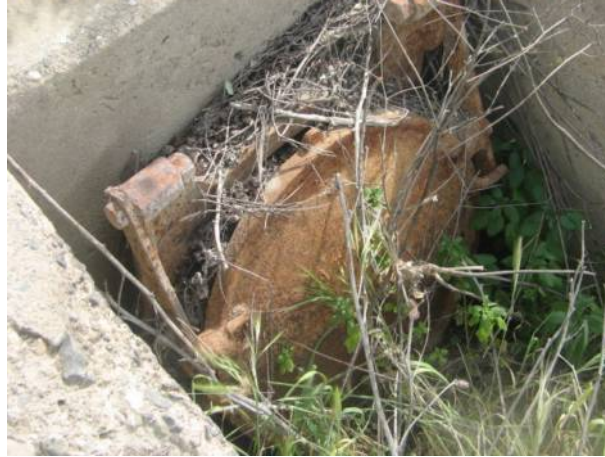
Levee Mile Report Line	10
Start Levee Mile	2.66
End Levee Mile	2.66
Location	Water Side
Category	Interior Drainage & Piping Systems
Item	Flap Gates

Flap gate blocked at LM 2.66

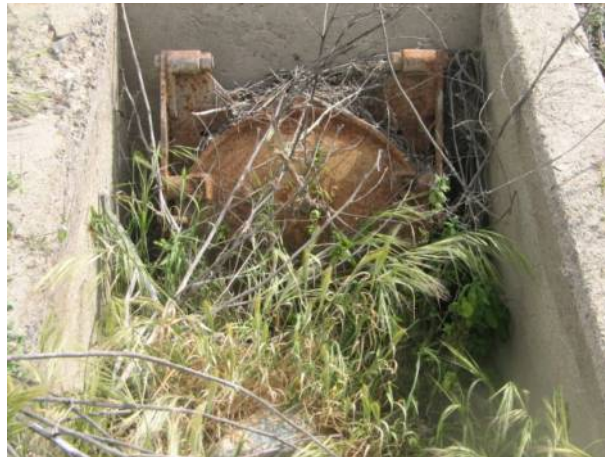
Levee Mile Report Line	10
Start Levee Mile	2.66
End Levee Mile	2.66
Location	Water Side
Category	Interior Drainage & Piping Systems
Item	Flap Gates

Front view of blocked flap gate at LM 2.62

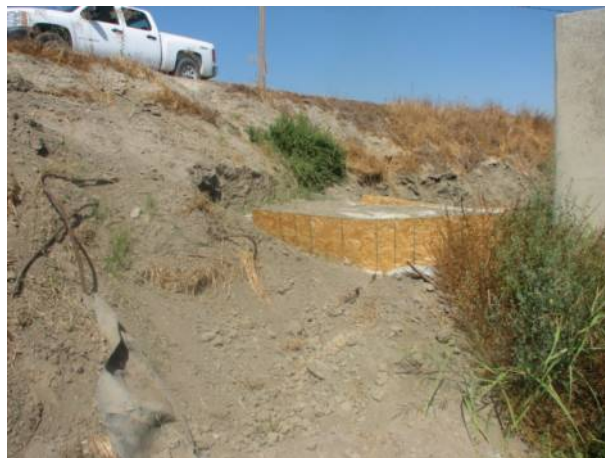
Levee Mile Report Line	17
Start Levee Mile	5.13
End Levee Mile	5.13
Location	Land Side
Category	Earthen Levee
Item	Encroachments

View of cut into landside slope

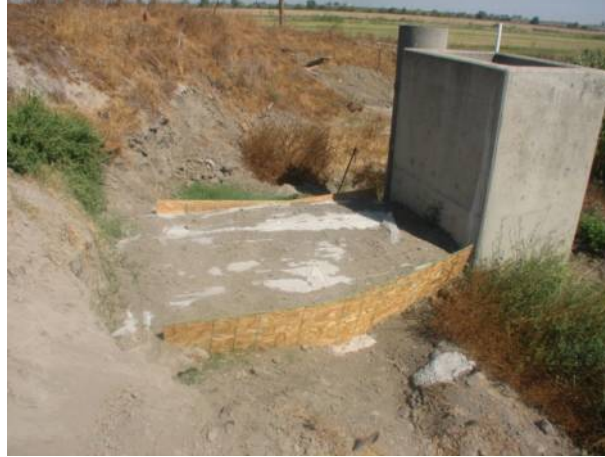
Levee Mile Report Line	17
Start Levee Mile	5.13
End Levee Mile	5.13
Location	Land Side
Category	Earthen Levee
Item	Encroachments

View of concrete stand pipe and encased pipe on landside toe.

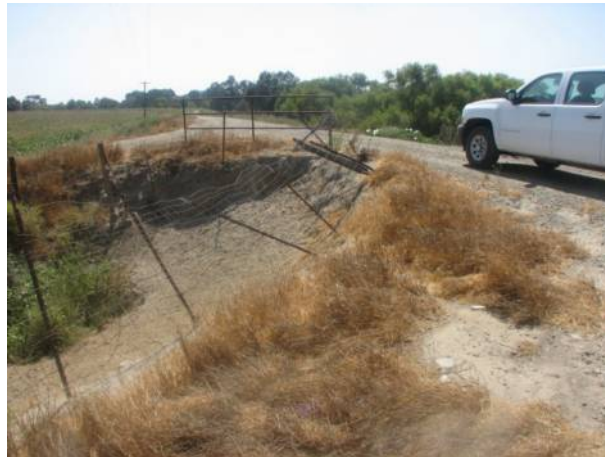
Levee Mile Report Line	22
Start Levee Mile	7.08
End Levee Mile	7.08
Location	Land Side
Category	Earthen Levee
Item	Slope Stability

Erosion located on landside slope above irrigation canal. Erosion cause by animal traffic

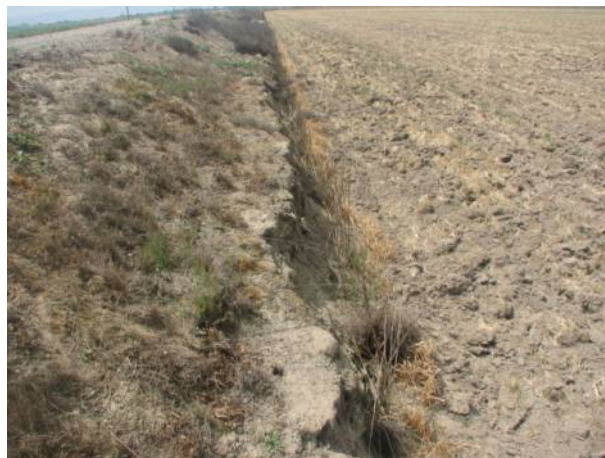
Levee Mile Report Line	24
Start Levee Mile	8.88
End Levee Mile	9.60
Location	Land Side
Category	Earthen Levee
Item	Encroachments

Looking from top of levee at erosion on landside toe.

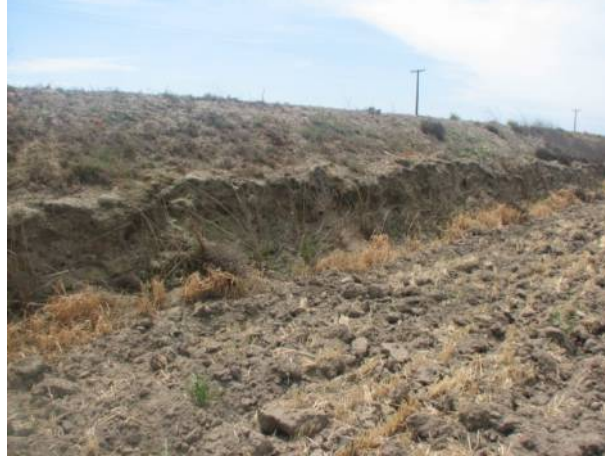
Levee Mile Report Line	24
Start Levee Mile	8.88
End Levee Mile	9.60
Location	Land Side
Category	Earthen Levee
Item	Encroachments

Looking west at landside erosion.

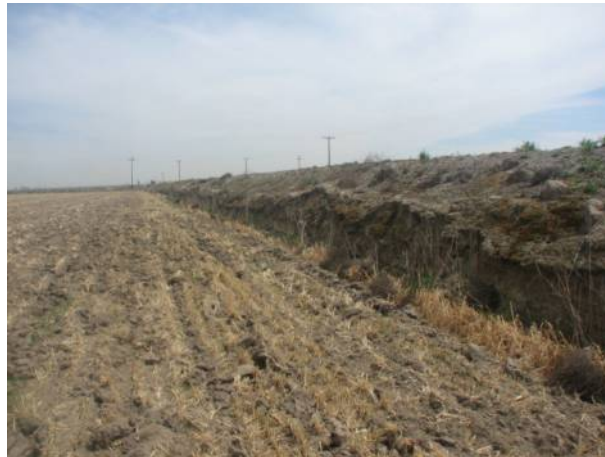
Levee Mile Report Line	24
Start Levee Mile	8.88
End Levee Mile	9.60
Location	Land Side
Category	Earthen Levee
Item	Encroachments

Looking north at erosion along landside toe.
